Capital Planning Committee Report

Dated January 6, 2011

POLICE DEPARTMENT FACILITY

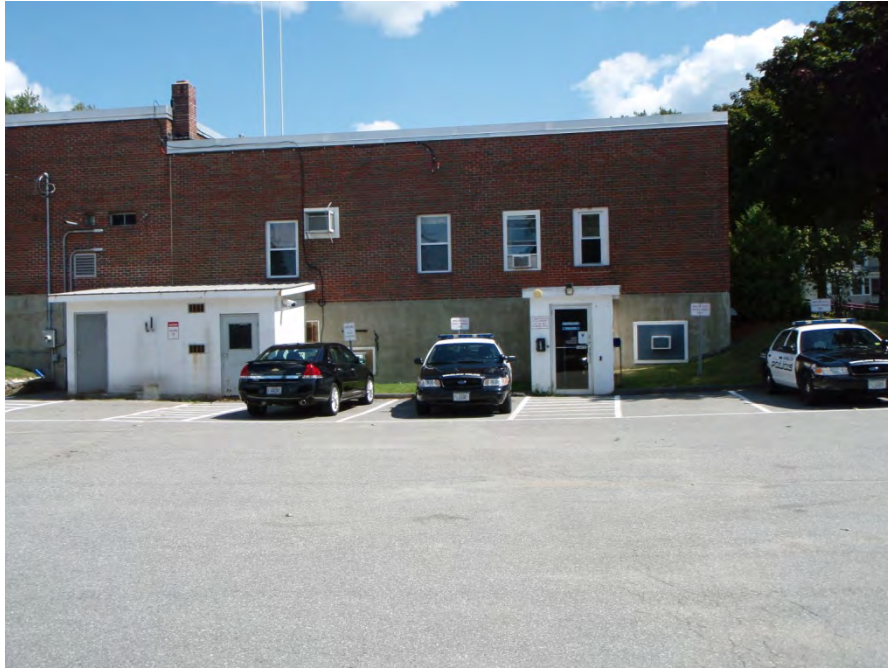
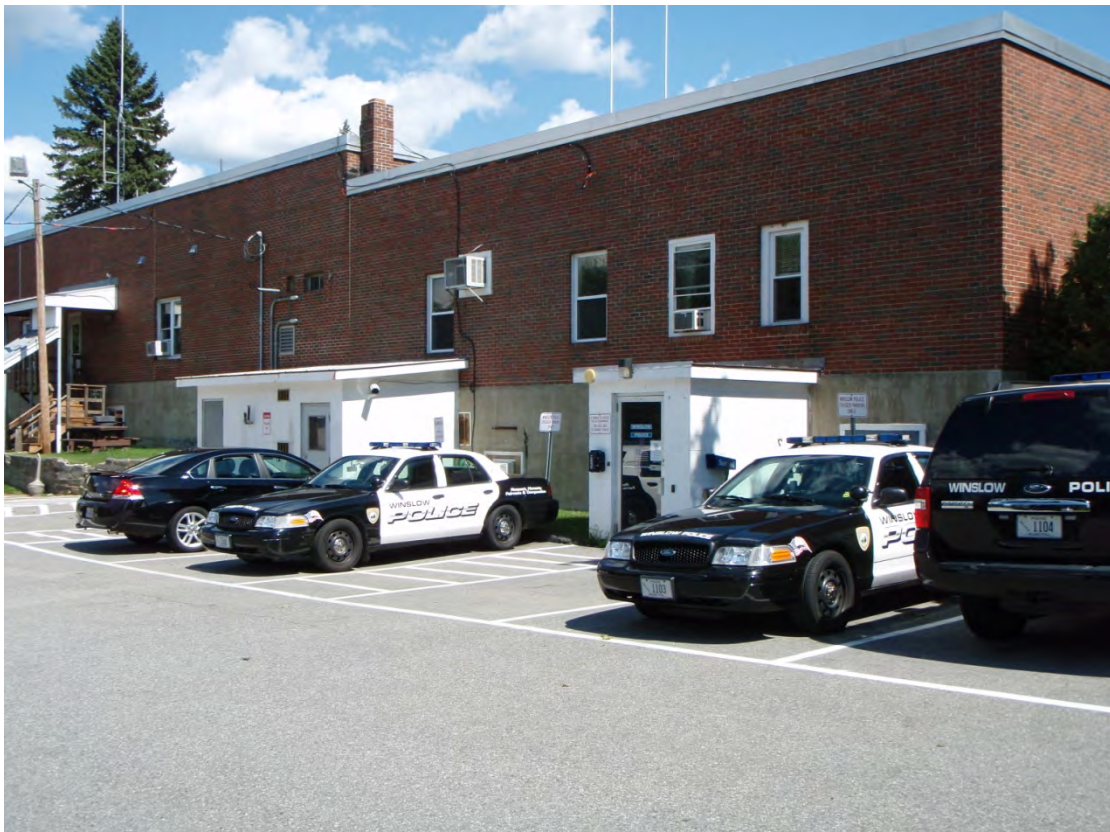
114 Benton Avenue

- 1) Main entrance utilizes three steps down, a landing and a fourth step. Concern is for officers, citizens and persons under arrest possibly being injured.
- 2) There is no handicap accessibility to the facility.
- 3) Officers must walk persons under arrest down a long hallway and across the interview/training/break room to reach the booking room.
- 4) Officers work room is small containing only a table and no desks or actual work areas and only two computers.

- 5) One back room must be utilized as an interview room, training room and officers break room.
- 6) Lieutenant and sergeant must share an office due to space limitations.

- 7) No air flow in any of the offices.
- 8) Detective is working out of the fire station due to air quality issues.
- 9) Booking room has only a metal ring attached to the wall for officer/prisoner safety.

- 10) Officers and persons under arrest must utilize the same bathroom.
- 11) Evidence room is very small and has no ventilation.
- 12) Locker room must be shared by male and female officers and is not secure. All employees from the building may enter at any time. There are no showers or sinks in the space which is being utilized as a locker room.

- 13) Some evidence must be stored in a large caged area with department files and equipment due to limited secure space.
- 14) There is no kitchen/break area for officers when working long shifts.

- 15) No secure area for officers to removed arrested persons from the police vehicles into the police station.

The committee recommends that this facility not be used as it is now and the Police Department relocated to a more suitable location as soon as possible. The town may want to form a committee for this purpose.

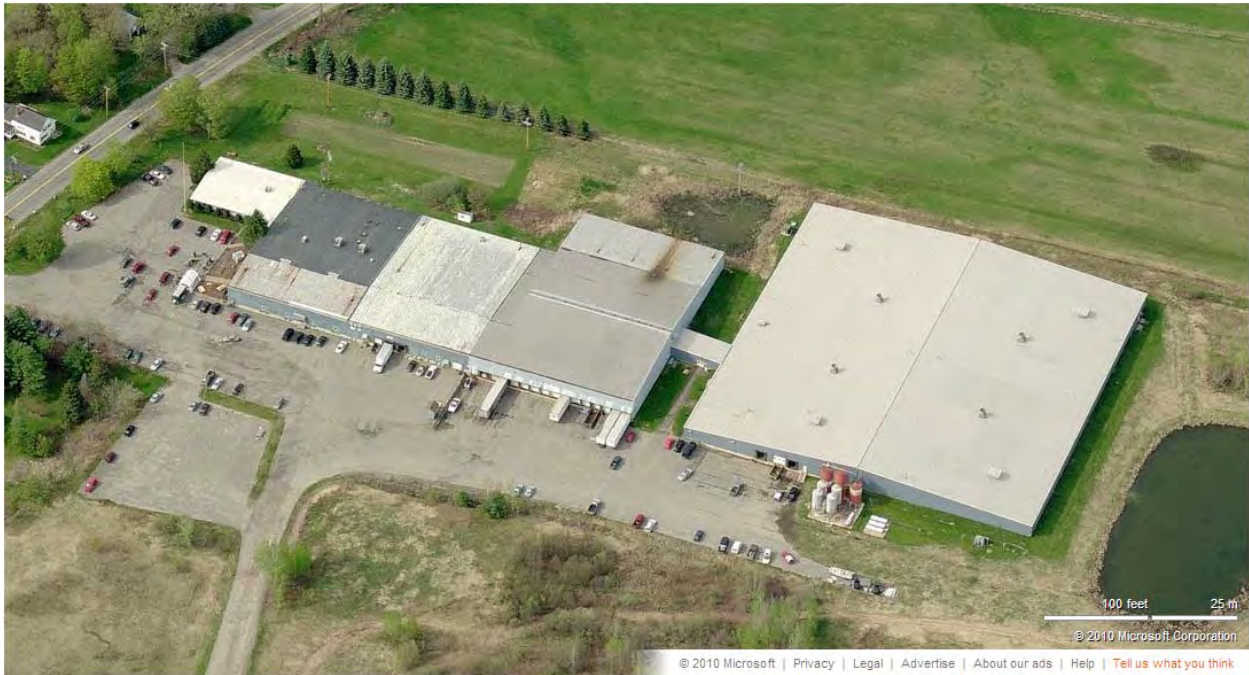
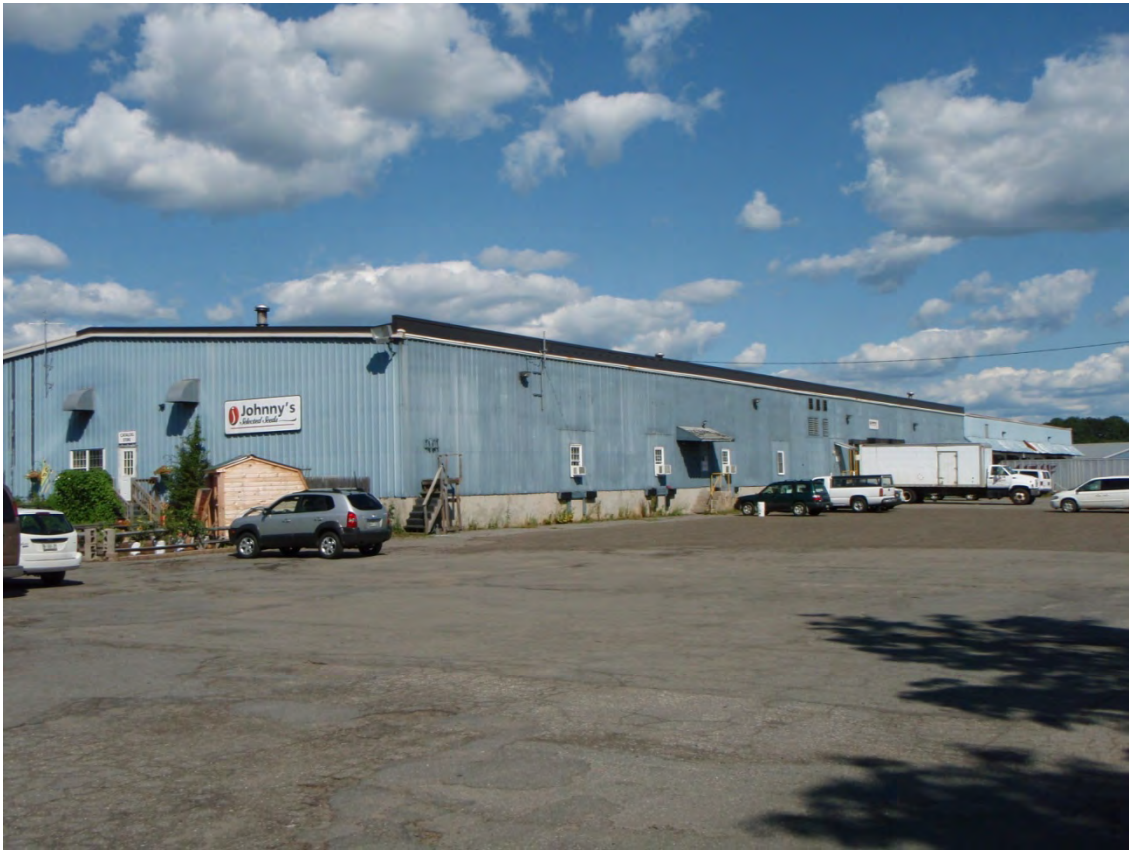
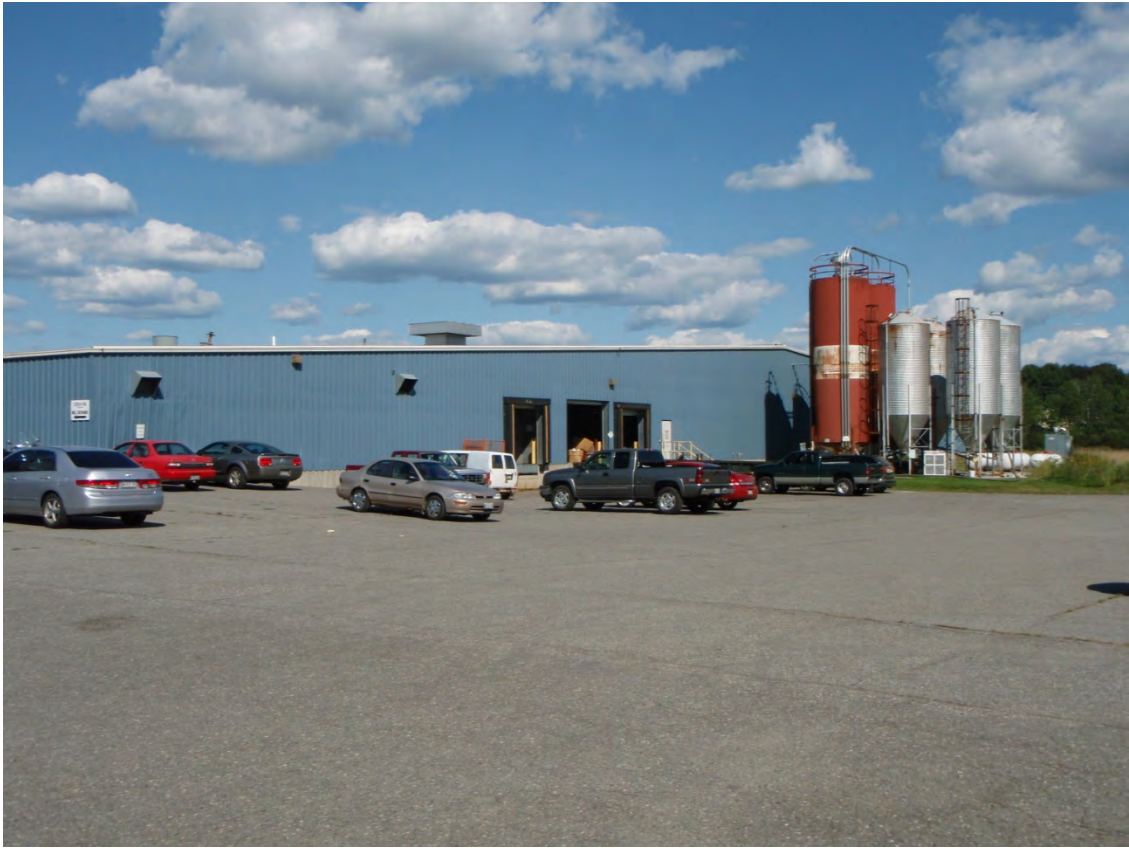
921 Benton Avenue

- a) **Issues and Concerns:**
 - i) The roof is leaking in numerous locations where there is some sort of roof exhaust or vent fixture.
2. **Johnny's Selected Seeds** – Occupies the older portion of the building. The Town has a lease agreement with Johnny's Selected Seeds until 2016. Over the past two years the town has invested \$185,091 in roof repair and replacement projects. The town has also upgraded the electrical system.

- a) **Issues and concerns:**
 - i) Their greatest concern is the Parking Lot, which needs to be rebuilt and paved at an approximate cost of \$197,000.

- (1) Fix the leaking roof.
- (2) Rebuild and pave the parking lot.
- (3) Implement a capital improvement plan to address future needs.

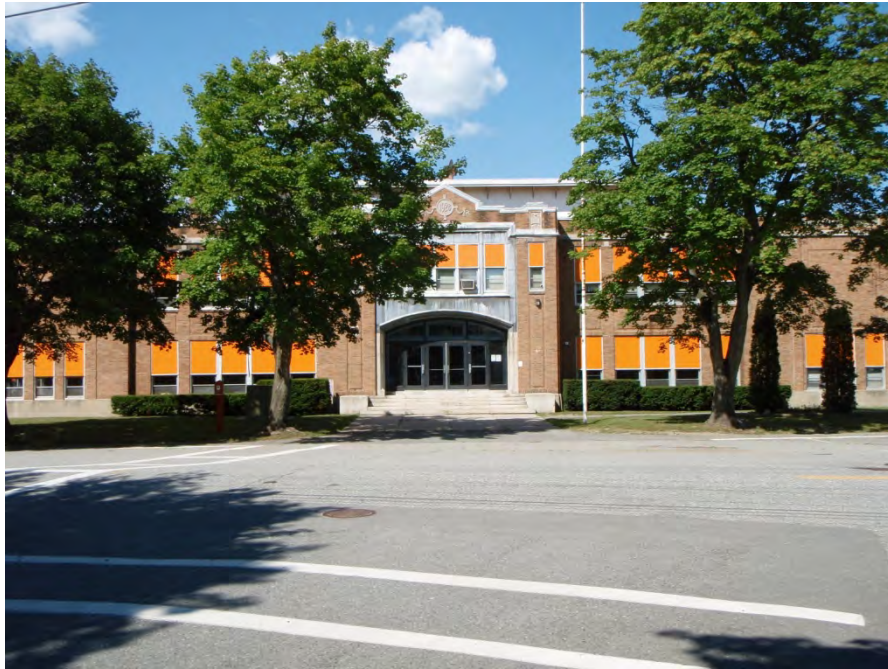
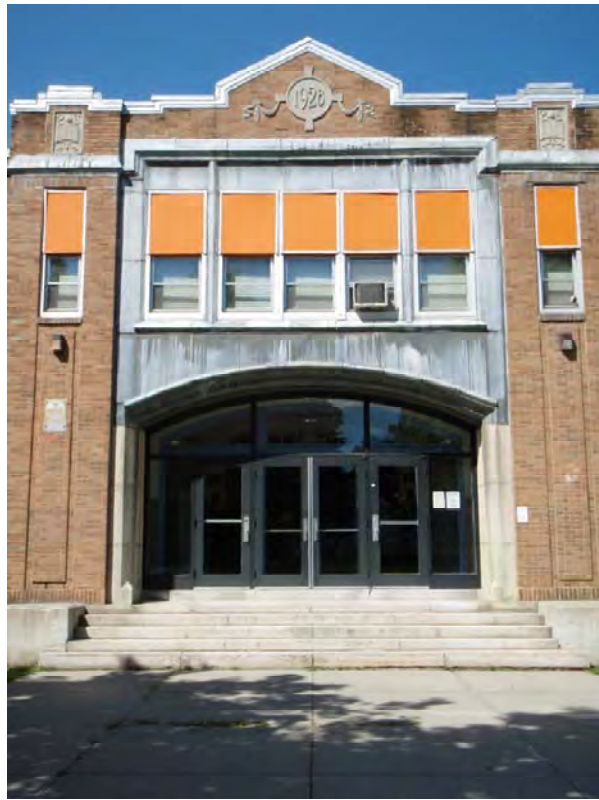
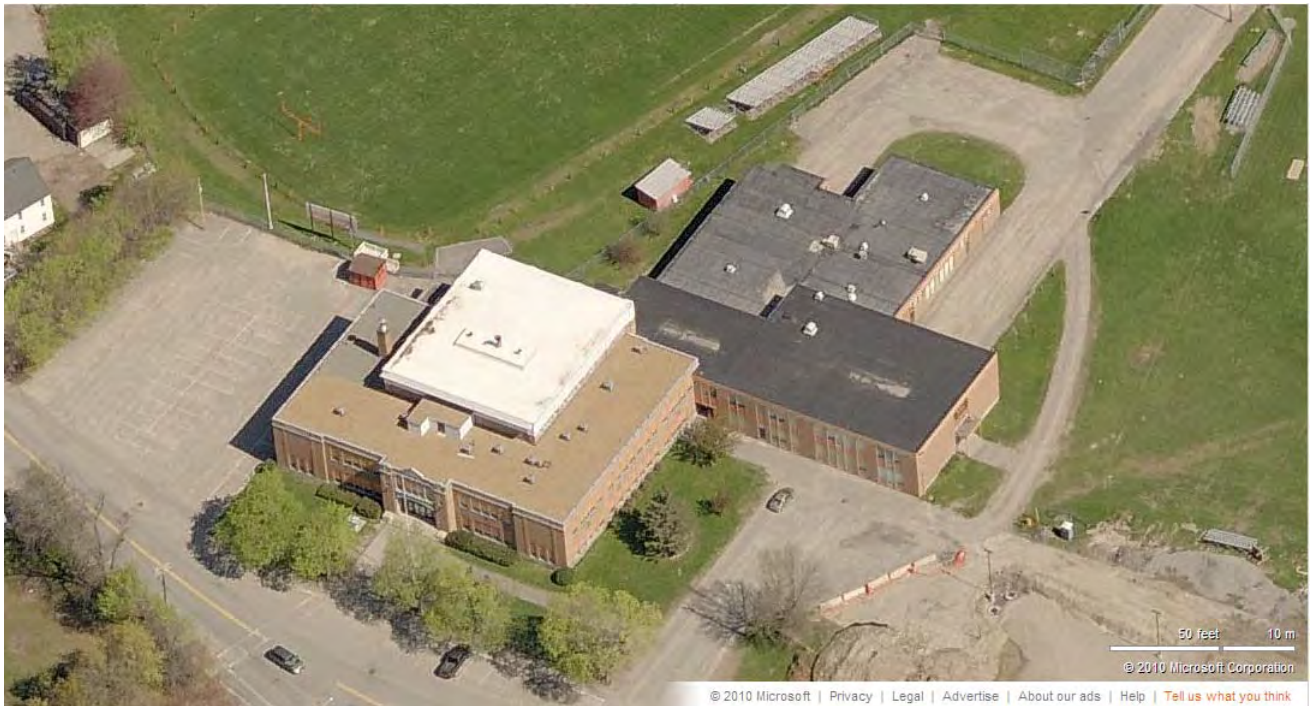
6 Danielson Street

The JHB is in need of repairs totaling approximately 3.2 million (see Appendix A). The most costly needed repair is the replacement of the Steam Piping System at a projected cost of 1.8 million. The JHB has two (2) boilers but only one (1) is functional. The non functioning boiler needs to be replaced at an approximate cost of \$100,000.

Due to the high cost of extending the useful life of this facility the Committee recommends that the Town work closely with the School Department in determining the most practical solution to meet the educational needs of the students attending the Jr. High.

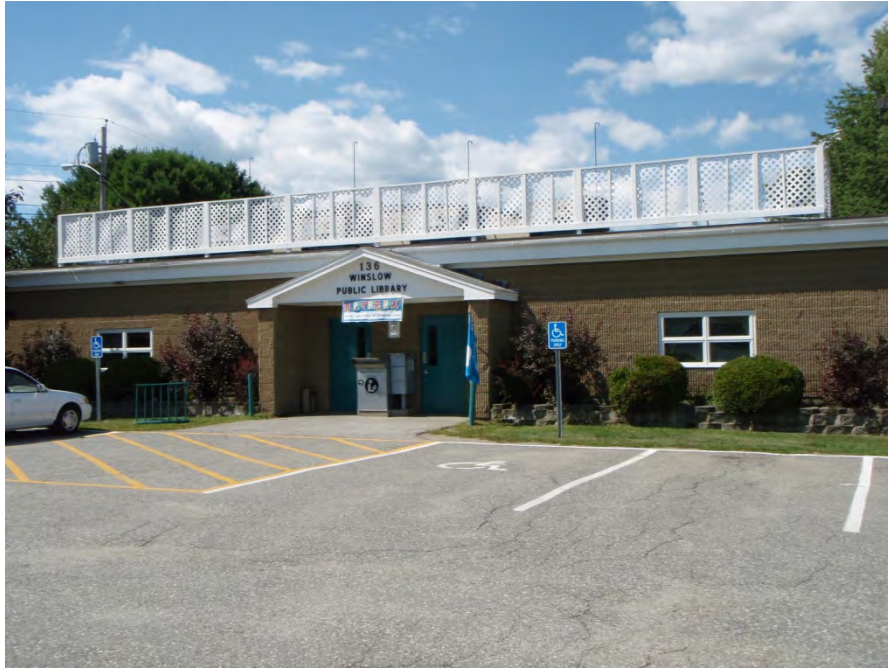
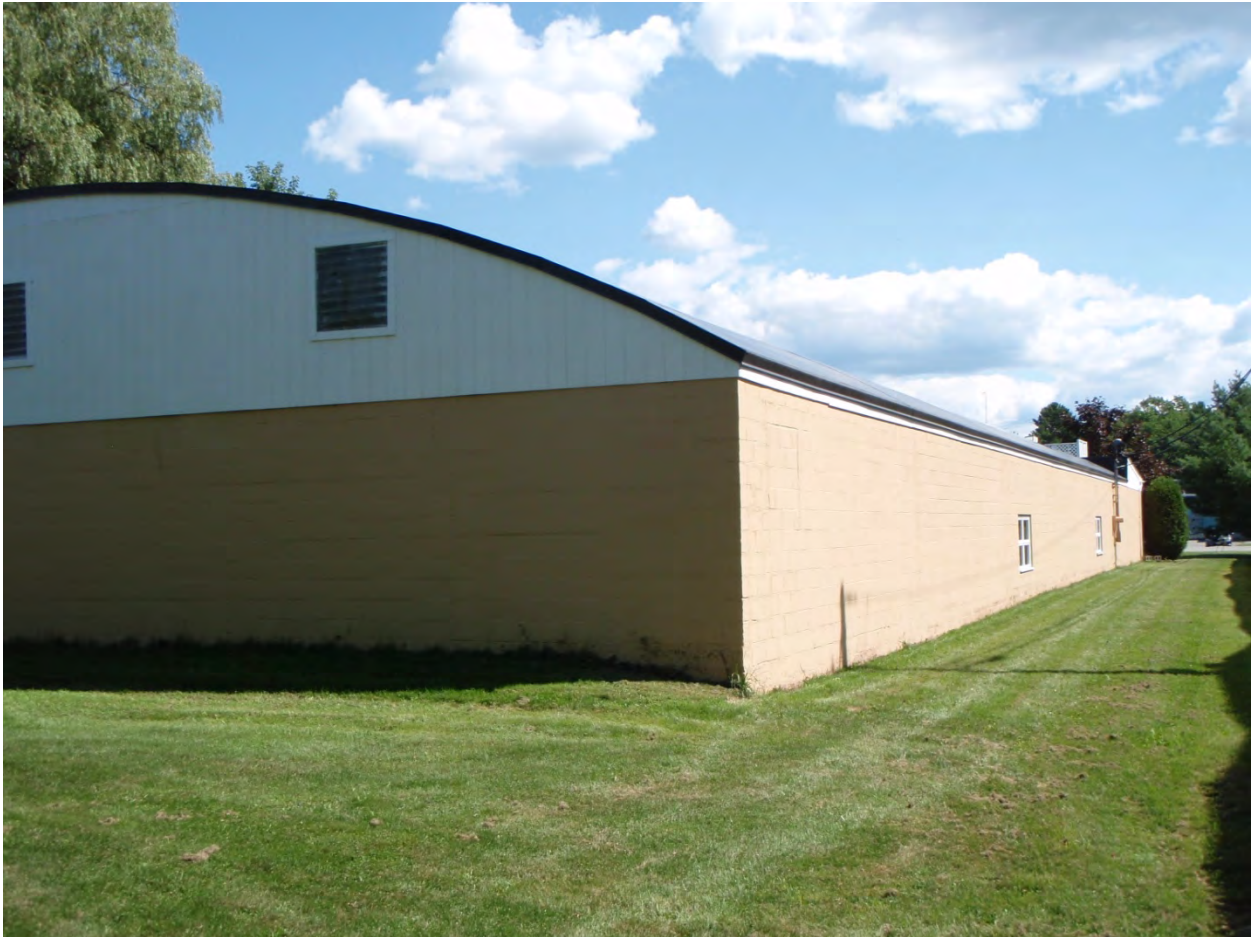
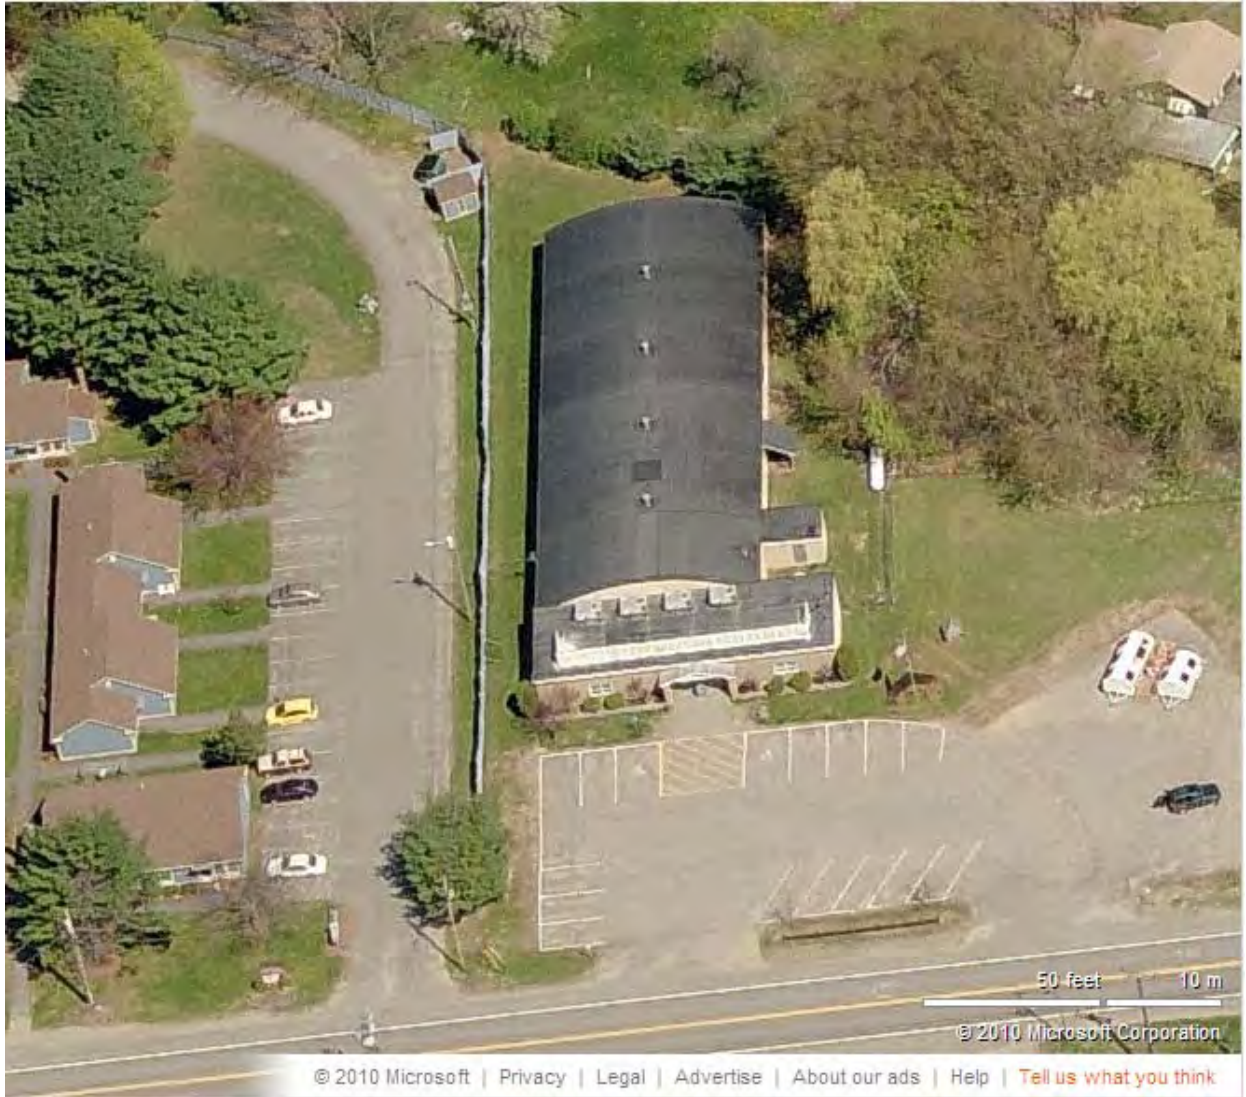
136 Halifax Street

1. Due to the structures age and roof design we are prevented from reducing the amount of heat loss through the ceiling.
2. Heat ducts are located at the front of the structure and the heat is not distributed evenly throughout the building.
3. The four (4) heating units need to be replaced at an estimated cost of \$20,000.

4. On certain mornings sewer odors and/or a musty smell can be detected in the entranceway. There has been a great deal of effort to identify the source of the odors without success.
5. There is very little room for storage.
6. At times a separate space for children is needed due to the noise generated by the children.

The Committee recommends that the four (4) heating units for the building be replaced at an estimated cost of \$20,000. With the heating units replaced the building could continue to be used for several more years.

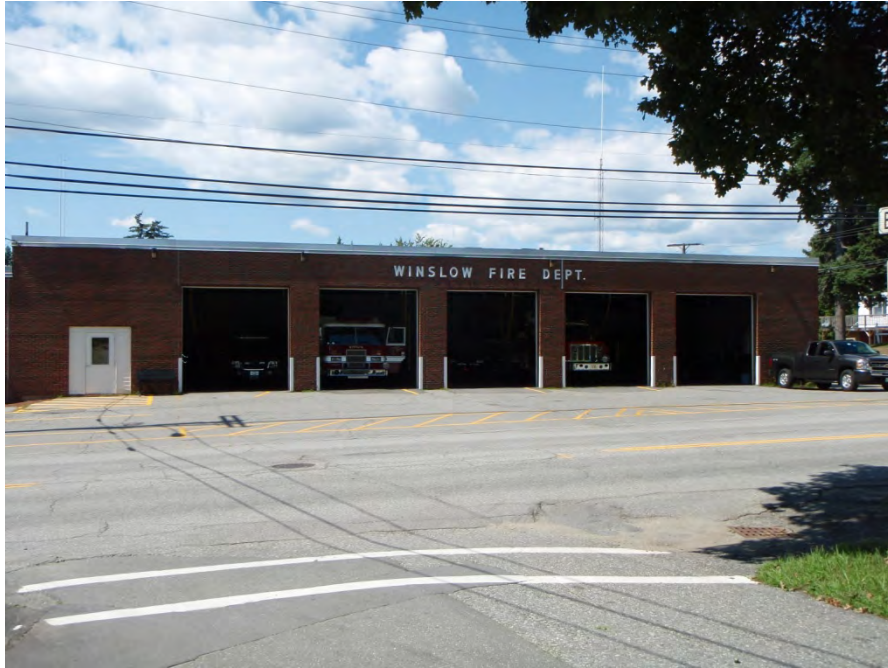
114 Benton Avenue

1. The roof is in need of substantial maintenance or replacement due to excessive leaking at times.
2. The apron from the Town Office Entrance to the driveway on the north end of the station should be redone.
3. Consider a floor plan reconfiguration to create storage area and a better location for the Chief's Office.

The Committee recommends that a comprehensive assessment of the roof be completed to identify the needed repairs to stop the periodic leaking and to extend the life of the roof.

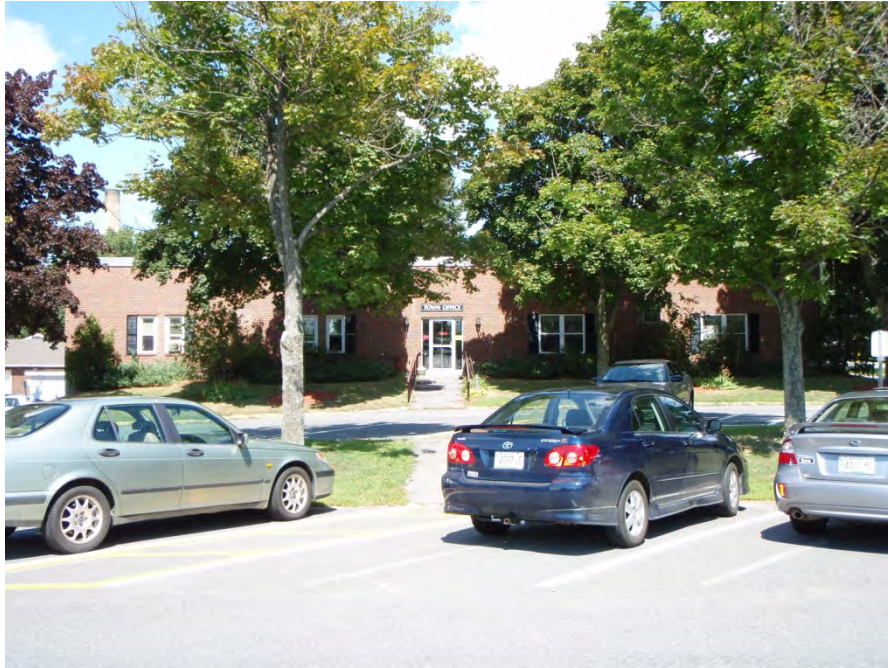
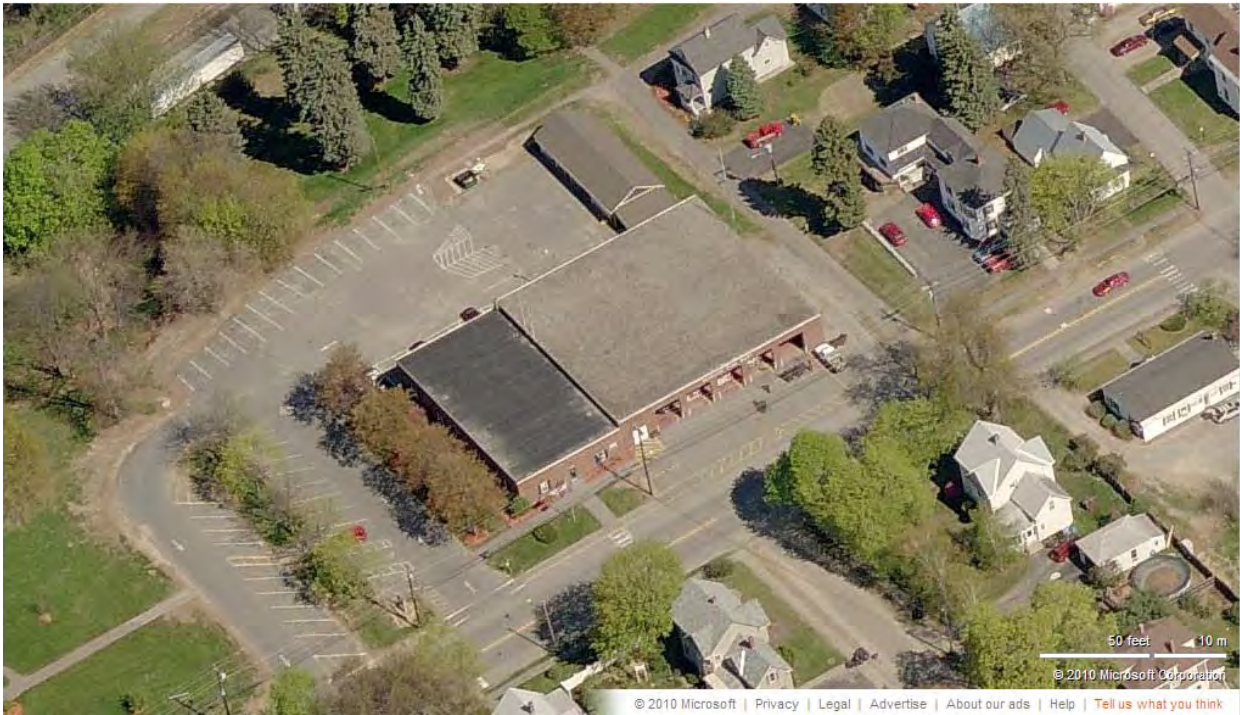
114 Benton Avenue

In November of 2010 Safety Works conducted air quality testing because staff were complaining of poor air quality. The testing revealed carbon dioxide concentrations higher than acceptable levels in the Code/Assessing office, which indicates inadequate air exchange.

1. Insufficient storage space.
2. Assessing and Codes could use more room.
3. Poor air quality due to inadequate air exchange.

The Committee recommends a solution be sought to address the poor air quality. The installation of an air handling/exchange system may be necessary.

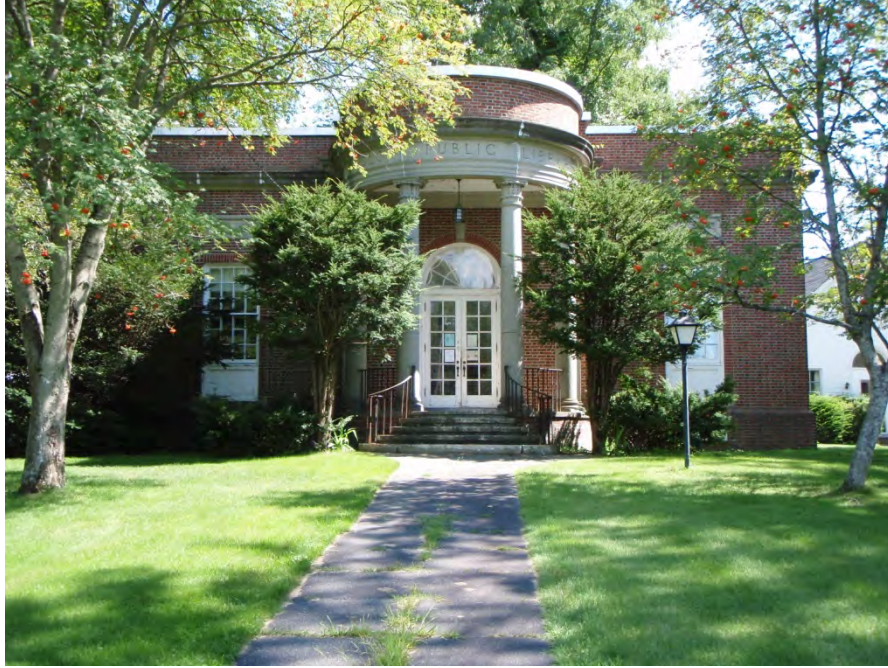
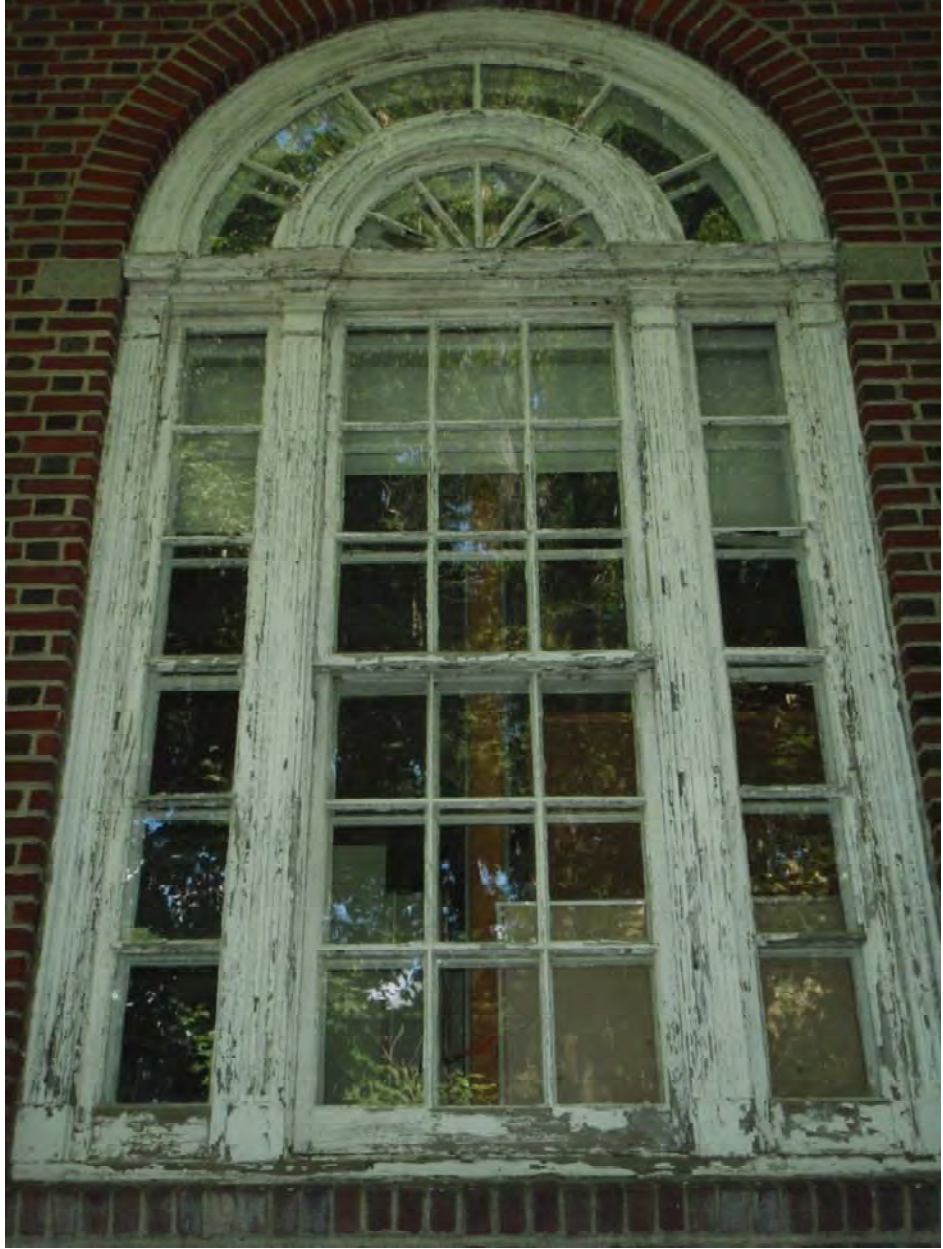
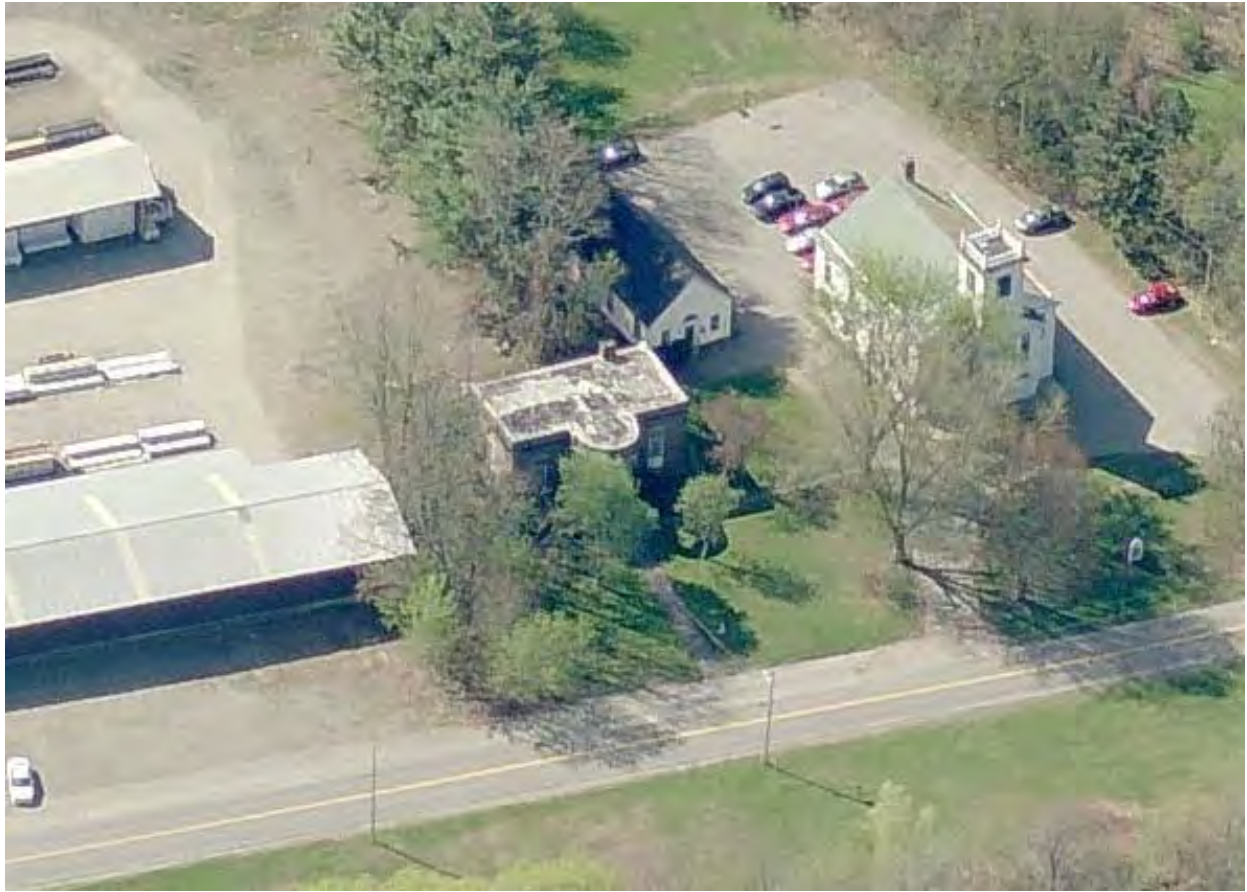
10 Lithgow Street

1. Window and window sills are in need of repair and painting.
2. The exterior masonry needs extensive maintenance.
3. Exterior stairway railings need to be replaced.

Due to the fact that the building does not serve a municipal purpose but is of historical importance to the town the Committee recommends that restoration and maintenance efforts be funded through grants and/or donations.

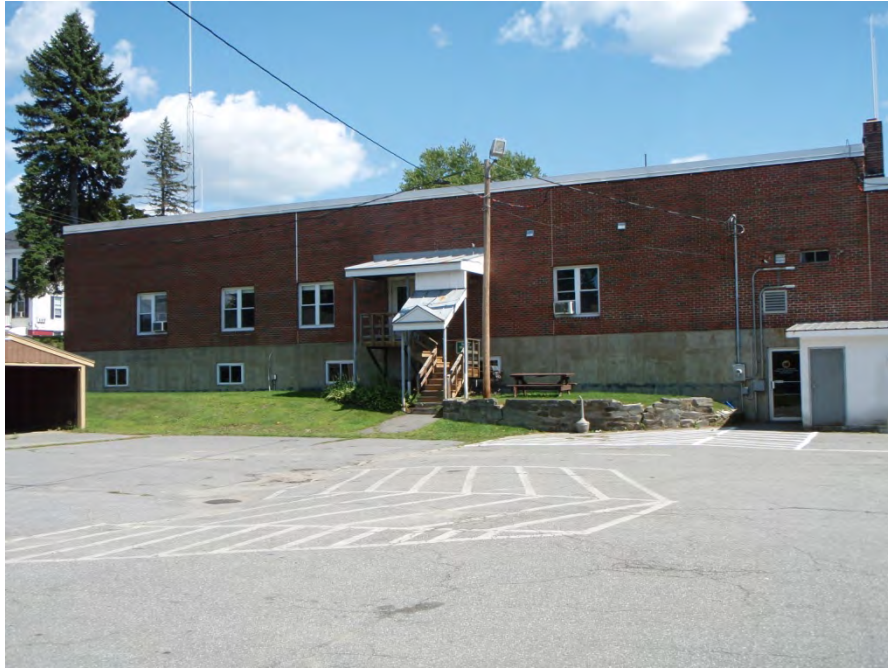
114 Benton Avenue

1. Space does not heat evenly in cold weather.
2. There are concerns about the age of the plumbing.

The Committee recommends that the facility's heating units be modified to provide an even distribution of heat.
